FATIGUE STRENGTH OF METAL SANDWICH

TYPE CONSTRUCTION.

FATIGUE STRENGTH OF
METAL SANDWICH TYPE CONSTRUCTION

In Partial Fulfillment of the Requirements
For the Degree of
Aeronautical Engineer

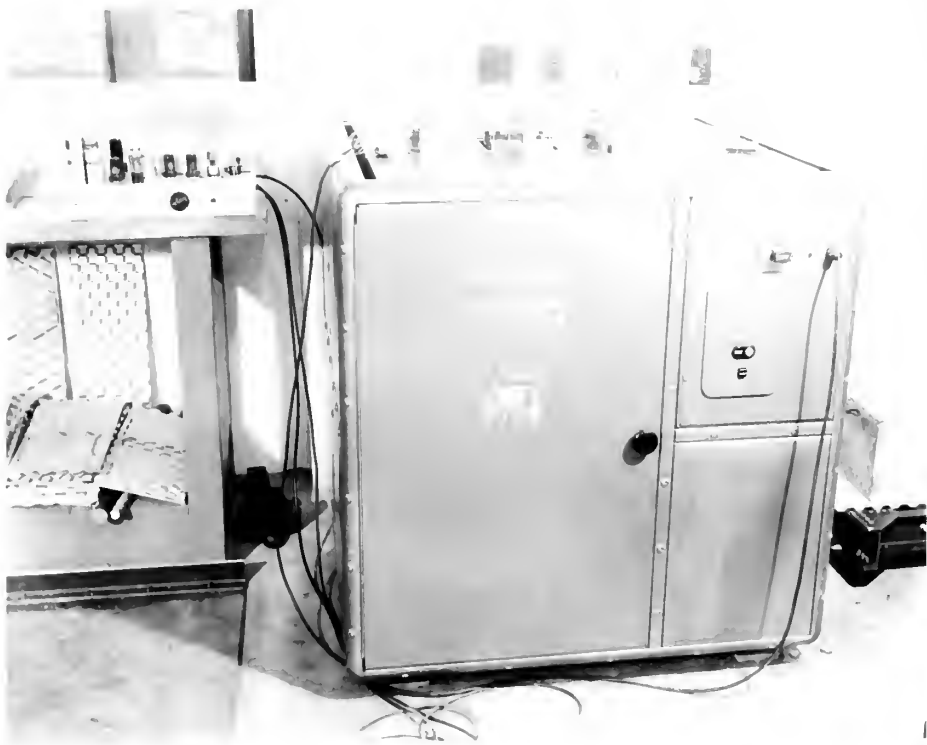
Figure 2

Testing Machine with Electronic Cut-off Circuit

steel rods, that were secured to the stationary part of the testing machine. The specimen's end was squeezed between two of these rods to prevent up or down motion, but to allow some motion along its length. Details of the loading adapter and testing machine set-up may be viewed in Figures 2, 3, and 10.

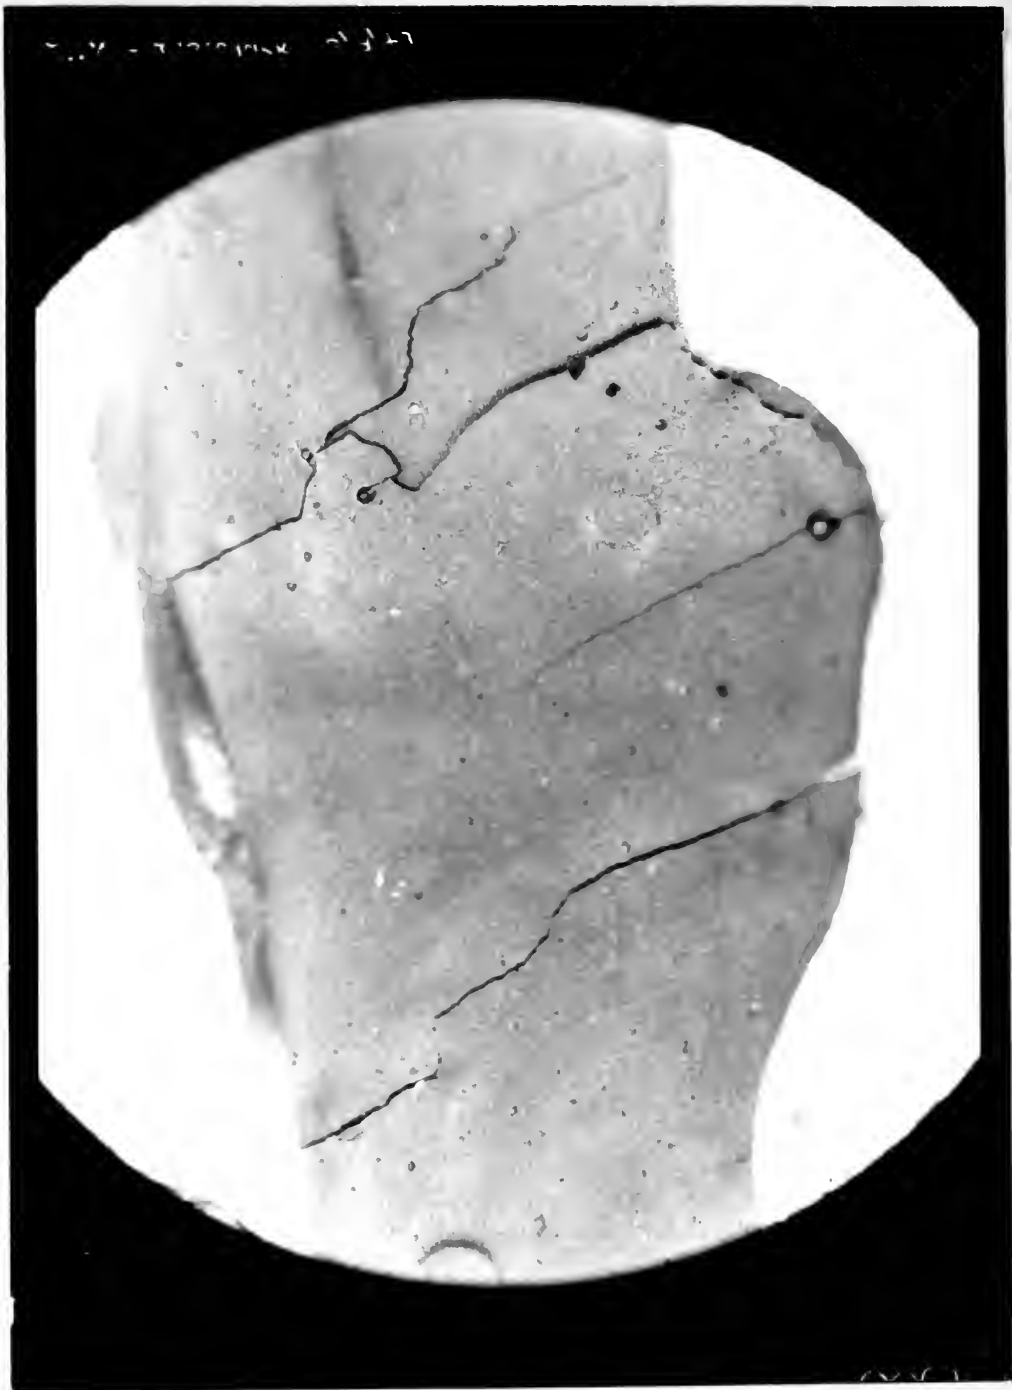
Photomicrograph of Crack Across Filament - Magnification 50 x

Figures 8 and 9 indicate the effectiveness of the crack detection. Figure 8 shows a crack across a saddle point with the graphite fracture ensuing. Figure 9 shows one of these cracks with the graphite and
